Re: Notice of Violation
Compliance Evaluation Inspection
MND981953045

COMPLIANCE EVALUATION INSPECTION REPORT

INSTALLATION NAME: Safety Kleen Systems, Inc.
U.S. EPA ID No.: MND981953045
LOCATION ADDRESS: 9261 Isanti Street Northeast
Blaine, Minnesota
NAICS CODE: 562112 – Hazardous Waste Collection
DATE(s) OF INSPECTION: August 19, 2014
U.S. EPA INSPECTOR: Todd C. Brown

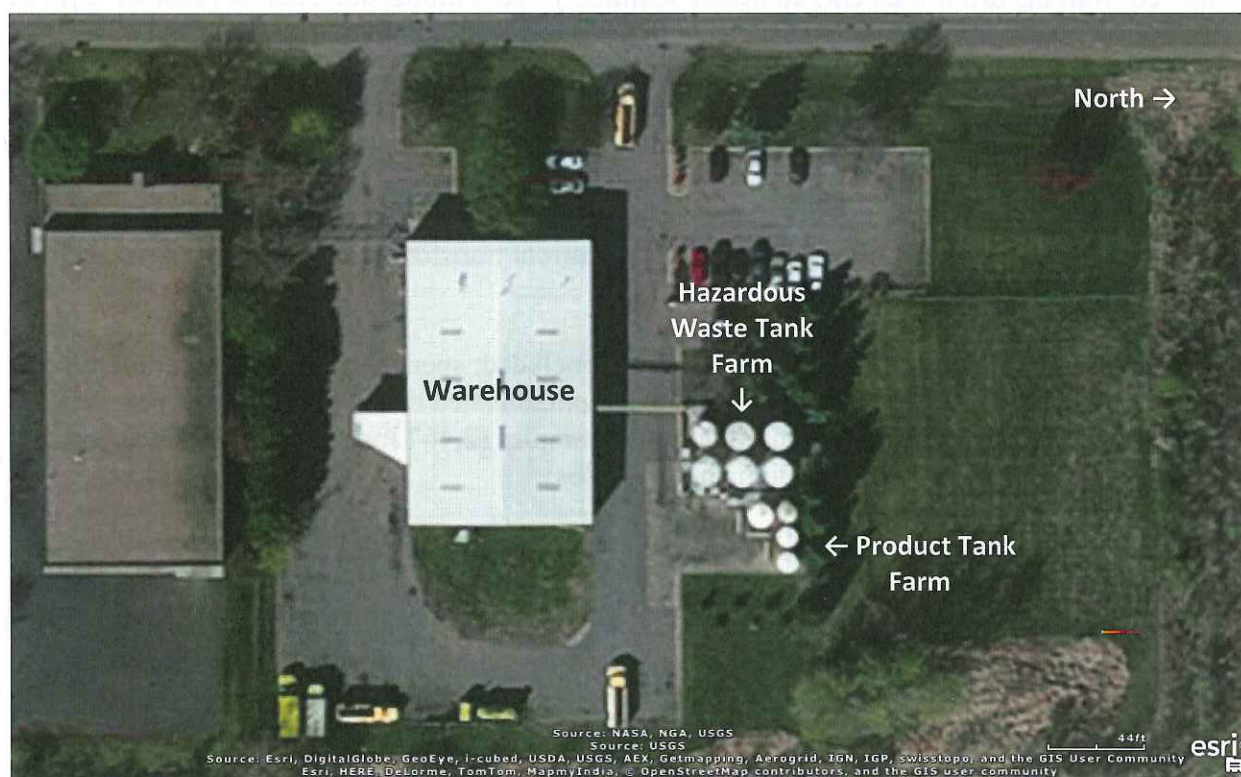
Safety Kleen's facility in Blaine, Minnesota is a permitted hazardous waste storage facility, hazardous waste transfer facility, and large quantity generator of hazardous waste. Its current RCRA storage permit was issued on June 9, 2011.¹ Facility structures include a warehouse and two out-door tank farms (Figure 1). There are approximately 17 employees at the location.

Figure 1: Aerial view of Safety Kleen Systems, Inc., 9261 Isanti Street Northeast, Blaine, Minnesota. The Return and Fill Area and Container Storage Area are located in the warehouse.

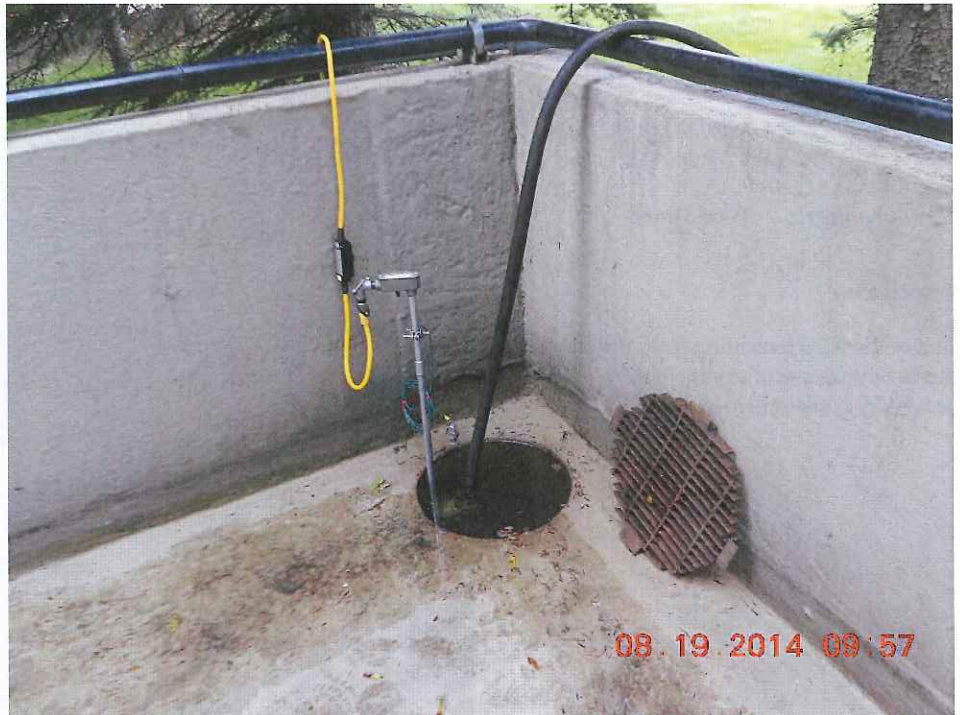
Photo Number 1

Rainwater was present in the sump of the hazardous waste tank system's secondary containment. A hose extended from the sump, over the side wall of the concrete liner, and onto the adjacent grass field (photographs 1 – 3). Mr. Knaus explained that Safety Kleen had recently pumped rain water out of the secondary containment and onto the field.

Sump for the secondary containment system housing the hazardous waste storage tank. A hose extended from the sump, over the side wall and onto the adjacent grass. The sump appeared to contain rain water.

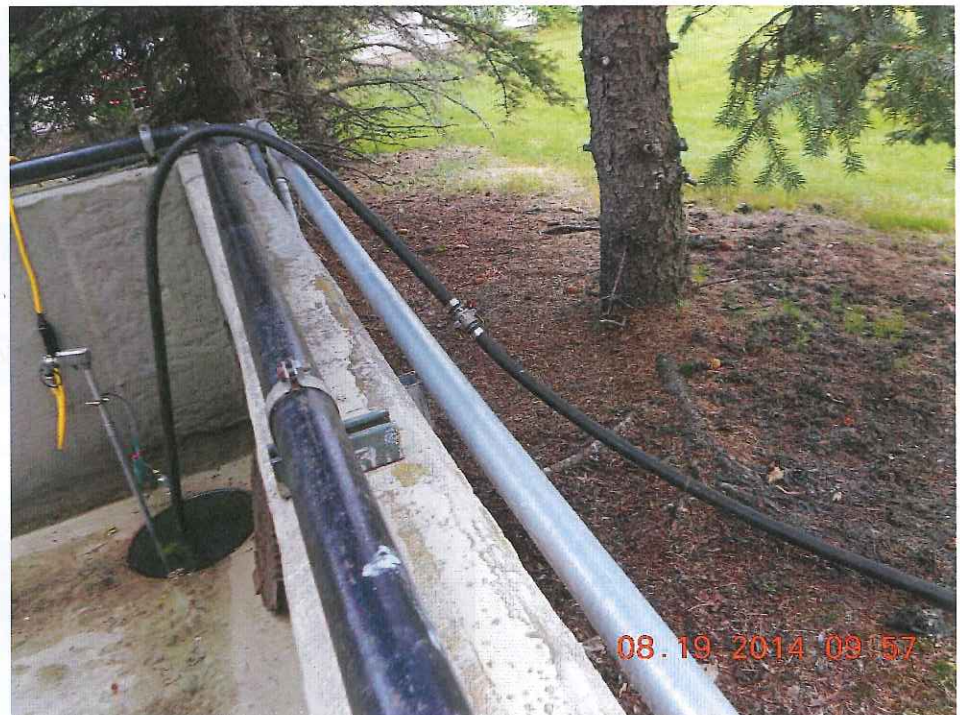
Photo Number 2

Hose extending from the sump of the hazardous waste storage tank's secondary containment system, over the side wall and onto the adjacent grass. The sump appeared to contain rain water.

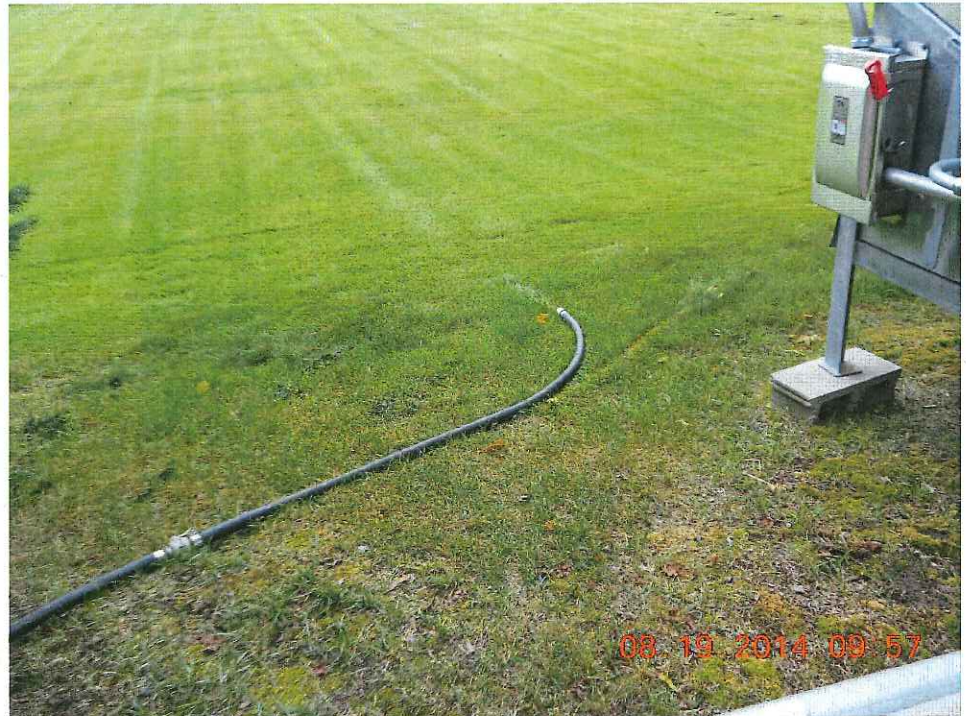
Photo Number 3
Photo Filename DSCN0661.JPG
Date/Time 8/19/2014
9:57:24 AM
Photographer Todd Brown

End of the hose extending from the sump of the hazardous waste storage tank's secondary containment system.

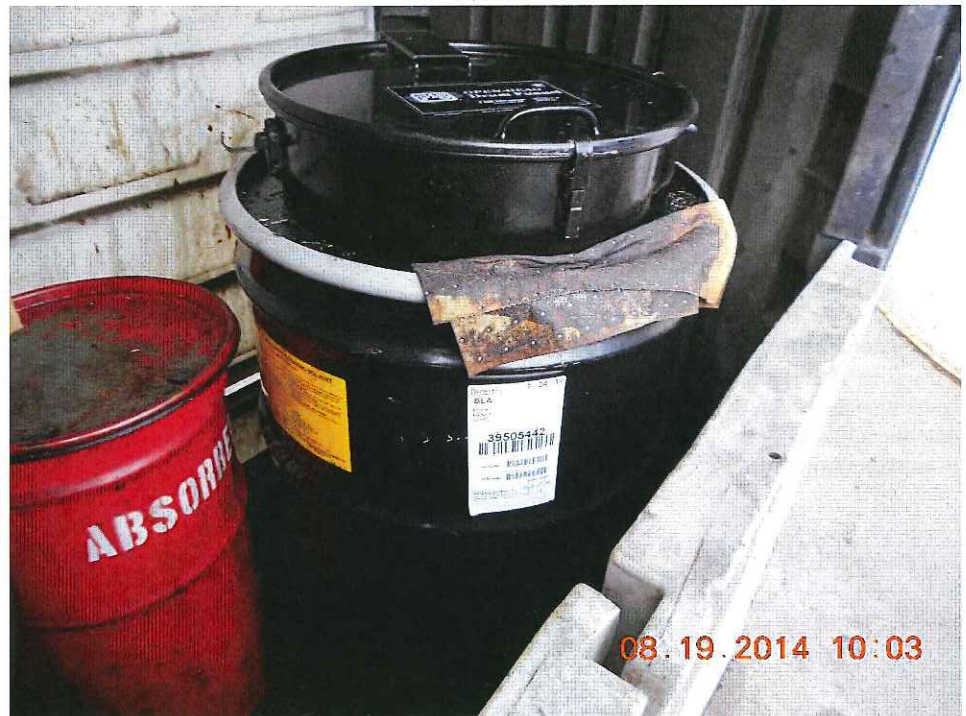
Photo Number 4
Photo Filename DSCN0662.JPG
Date/Time 8/19/2014
10:03:20 AM
Photographer Todd Brown

One 55-gallon container of "non-hazardous" absorbent material contaminated with oil was located in a bin, just outside of the hazardous waste tank farm (photograph 4).

Container for accumulation of absorbent material contaminated with oil. The container was located in a bin outside of the secondary containment system for the hazardous waste storage tank.

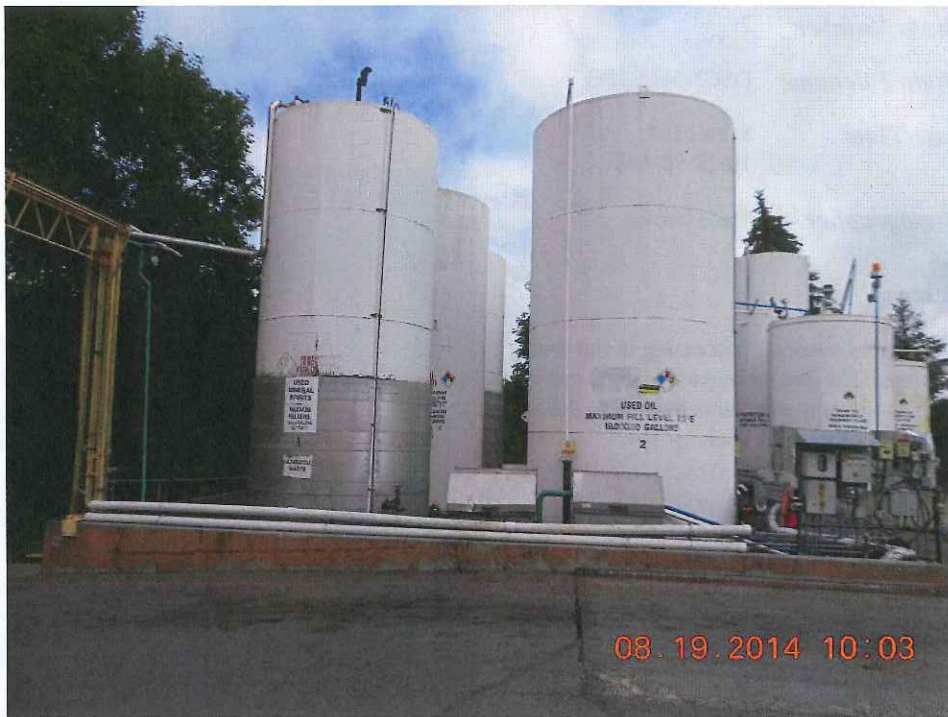
Photo Number 5

The level gauge for the tank labeled, "Oily Water", registered 10 feet 7 inches. According to Mr. Knaus, the tank actually contained used oil. The tank was not labeled as used oil.

Hazardous waste storage tank (left) and
used oil storage tank (right).

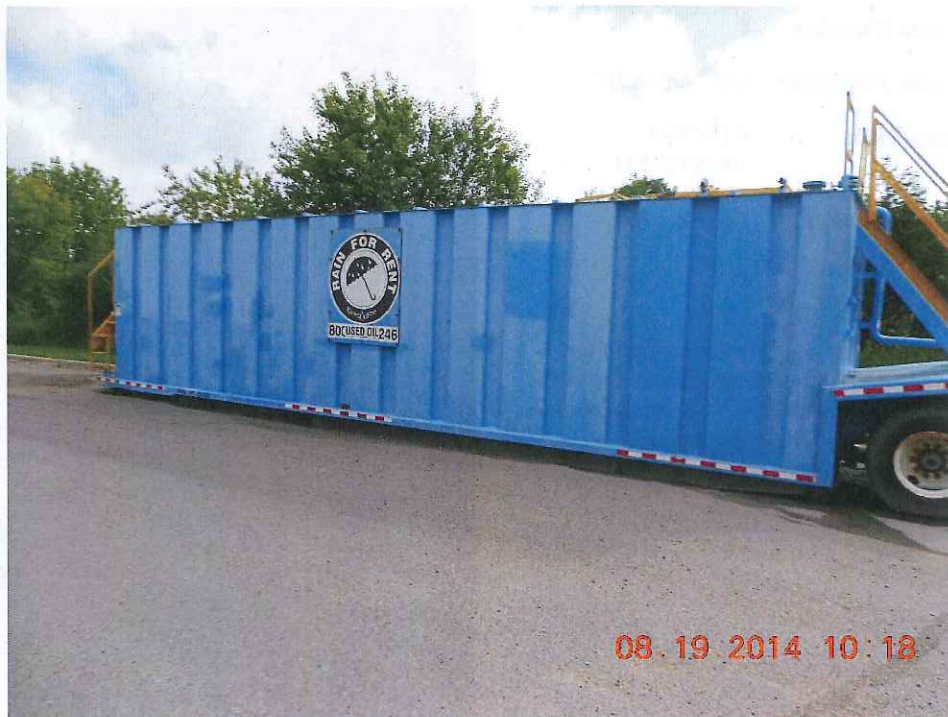
Photo Number 6

A frac tank for used oil storage was located to the east of the warehouse (photograph 6). The unit was labeled, "Used Oil."

Used oil fractionation tank located east of
the warehouse.

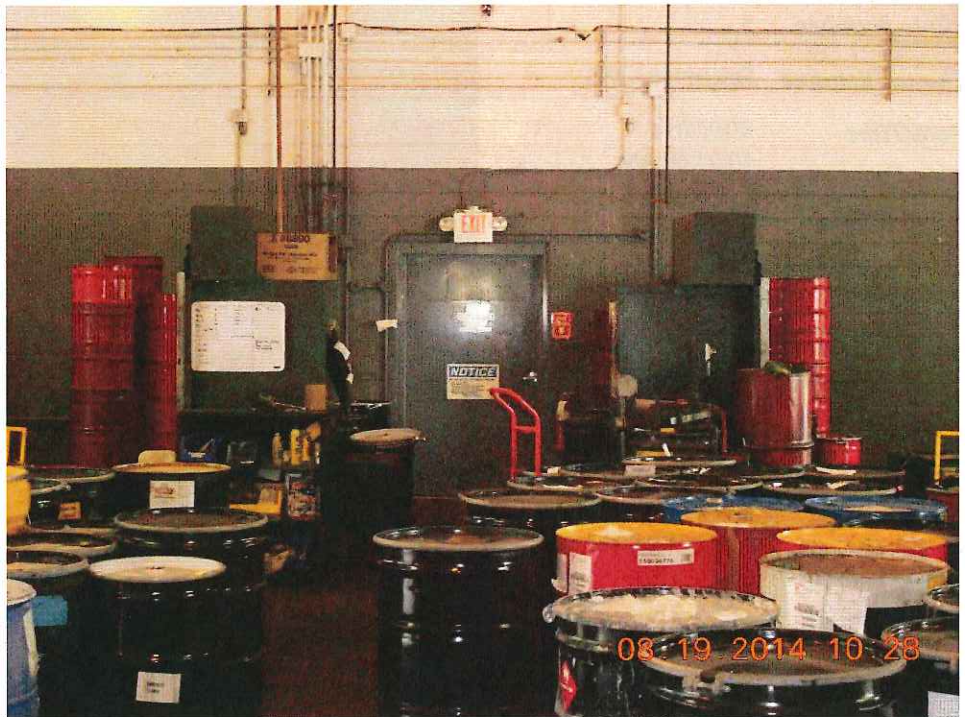
Photo Number 7
Photo Filename DSCN0665.JPG
Date/Time 8/19/2014
10:28:58 AM
Photographer Todd Brown

Numerous containers of hazardous waste were present at the Return and Fill Area; the portion of the warehouse where the drum washers are located (photograph 7). At the time of the inspection, a single operator was actively emptying containers into one of the drum washers.

Containers awaiting processing in the drum washers. The two drum washer units can be seen as the gray structures located to the left and right of the exit door.

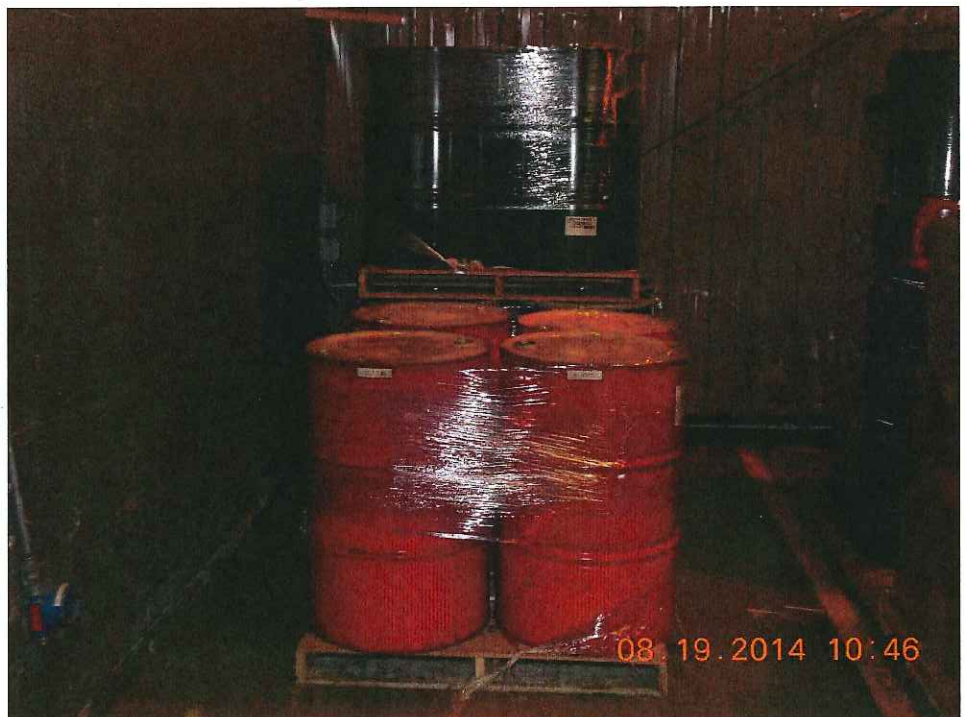
Photo Number 8
Photo Filename DSCN0666.JPG
Date/Time 8/19/2014
10:46:06 AM
Photographer Todd Brown

Numerous containers of hazardous and non-hazardous waste were present at the CSA (photographs 8-11). These included waste undergoing "10 day" transfer, waste generated at the facility, and off-site waste accepted for permitted storage (i.e., not 10 day transfer wastes). All of the containers of hazardous waste appeared to be appropriately labeled and dated. Specific hazardous waste streams observed included paint waste, branch debris, and brake cleaner.

Wastes awaiting off-site transfer in the Container Storage Area. All but one of the containers was labeled as a non-hazardous waste or used oil. One container was labeled as hazardous paint waste.

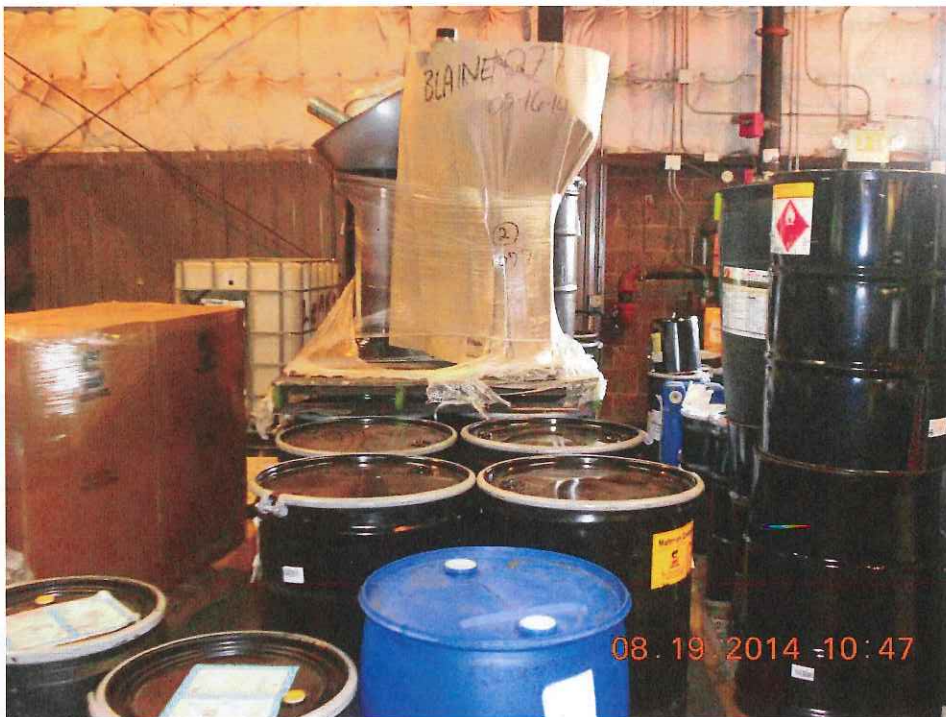
Photo Number 9

Containers of hazardous waste generated on-site, and non-hazardous waste received from off-site, located in the Container Storage Area. The hazardous waste consisted of "debris" removed from the drum washers (see photograph 10).

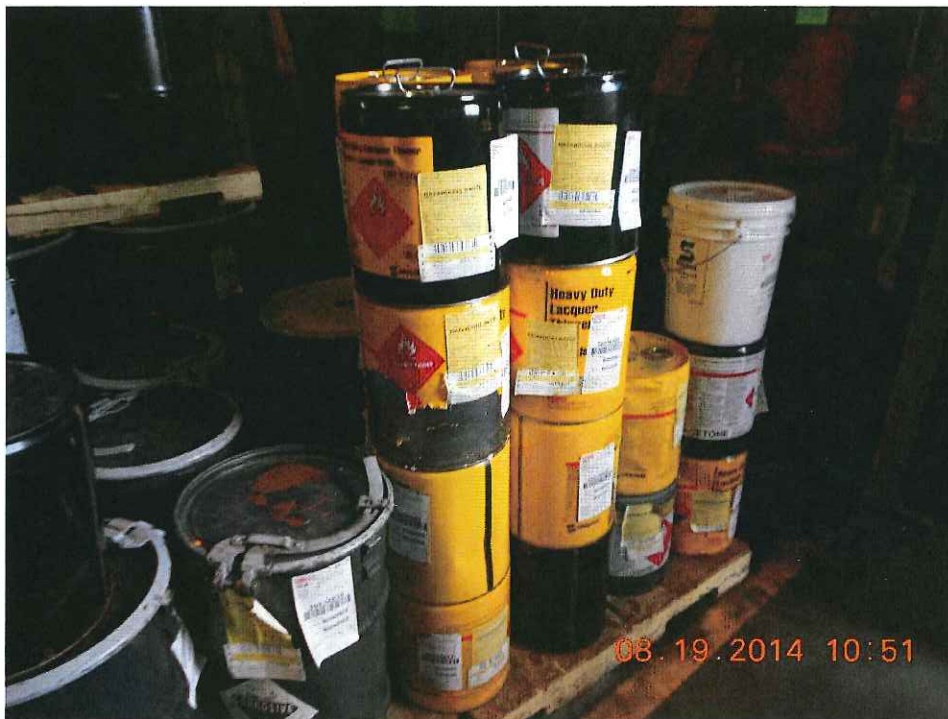
Photo Number 11

Containers of hazardous waste received from off-site located in the Container Storage Area. The contents included waste paint and break cleaner.
